Manhole Inspection Summary

Manhole # S43SS_028MH

Insp Date: **2/27/07 10:14 AM**

Location Address: **2651 AISQUITH ST**

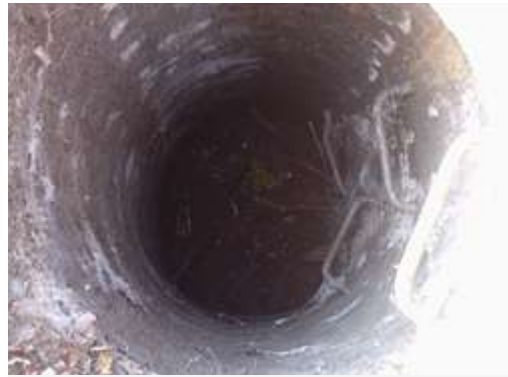
Top View

Channel debris.

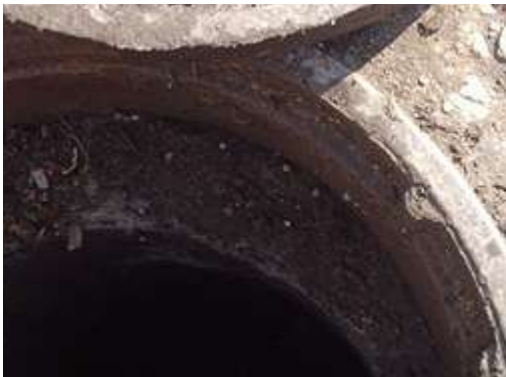
Defect

Frame Offset: **3** (in.)

Condition: ☐ Sound ☐ Cracked ☐ Root Intrusion ☐ Loose Brick ☒ **Deteriorated**

Infiltration: ☐ None ☒ **Joint** ☐ Cracks ☐ Mortar ☐ Roots ☒ **Wall**

Frame leaks. Frame offset. Adjustment deterioration and infiltration.

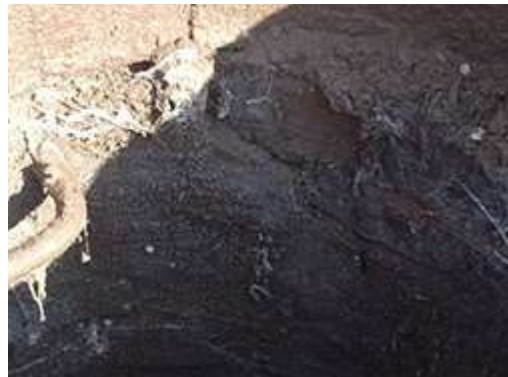
Defect

Frame leaks. Frame offset. Adjustment deterioration and infiltration.

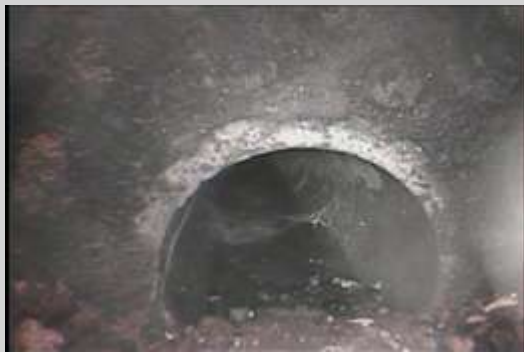
8 in. Circular Gravity Sewer
Pipe Out @ 12 O'Clock

Deposits: ☐ None ☒ **Mud** ☐ Sludge ☒ **Debris** ☐ Grease

Silt Depth: **1** (in.) Deposits Extent: **Light**
